SPACE TRANSPORTATION SYSTEM
Lyndon B. Johnson Space Center
Houston
Harris County
Texas

HAER No. TX-116

SPACE TRANSPORTATION SYSTEM HAER No. TX-116

Date: November 2012

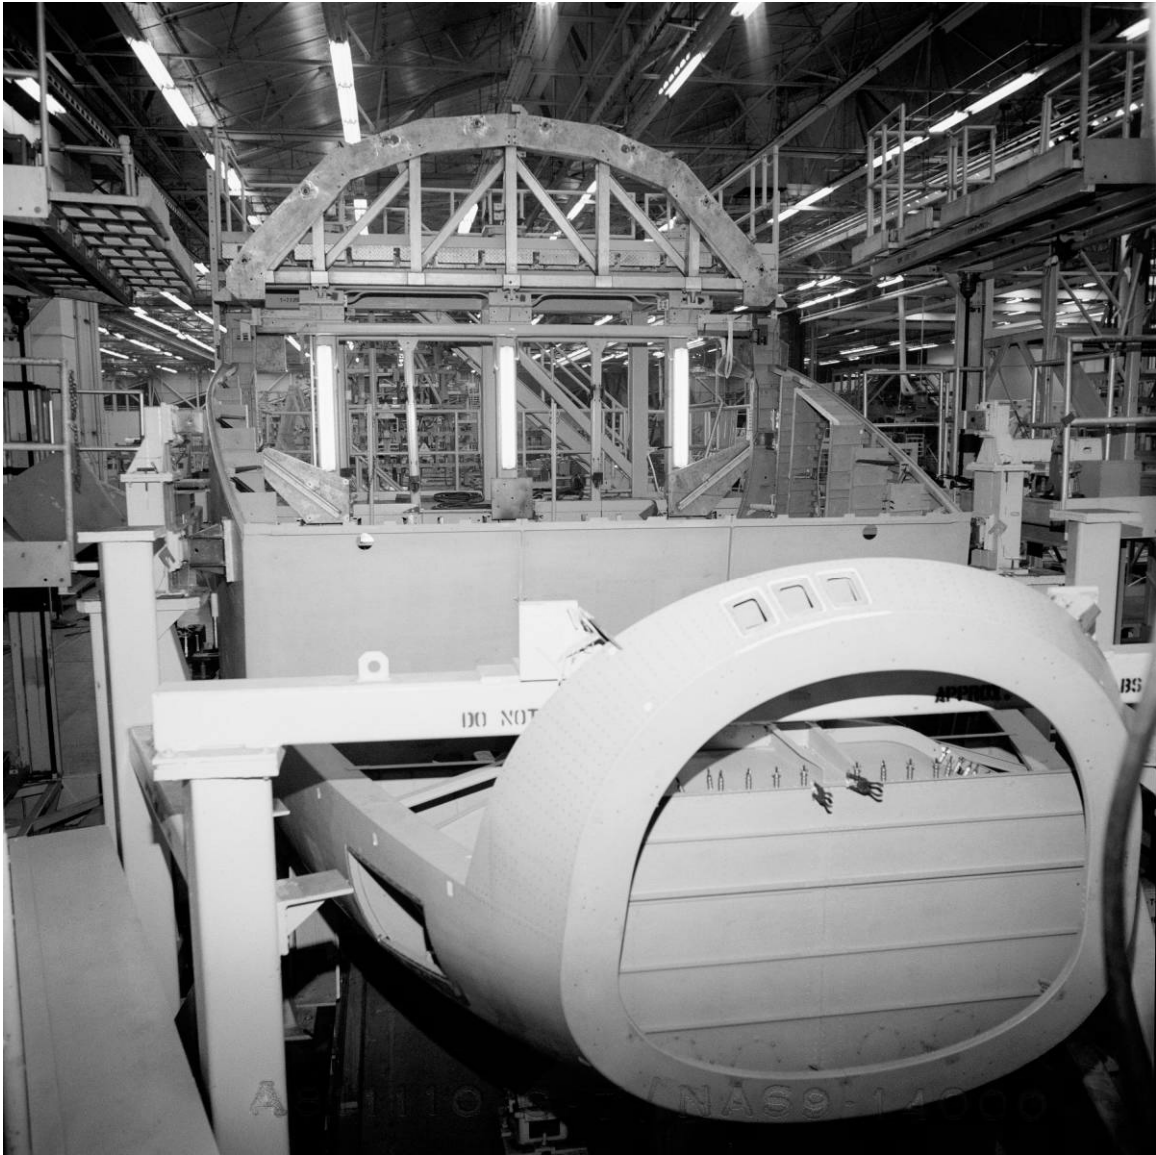
Figure B-2. Manufacturing of *Discovery's* lower forward fuselage, NAR Building 290, Downey, California, November 10, 1981.
Source: NASA, Johnson Space Center Image Repository, JSC2010-03198.

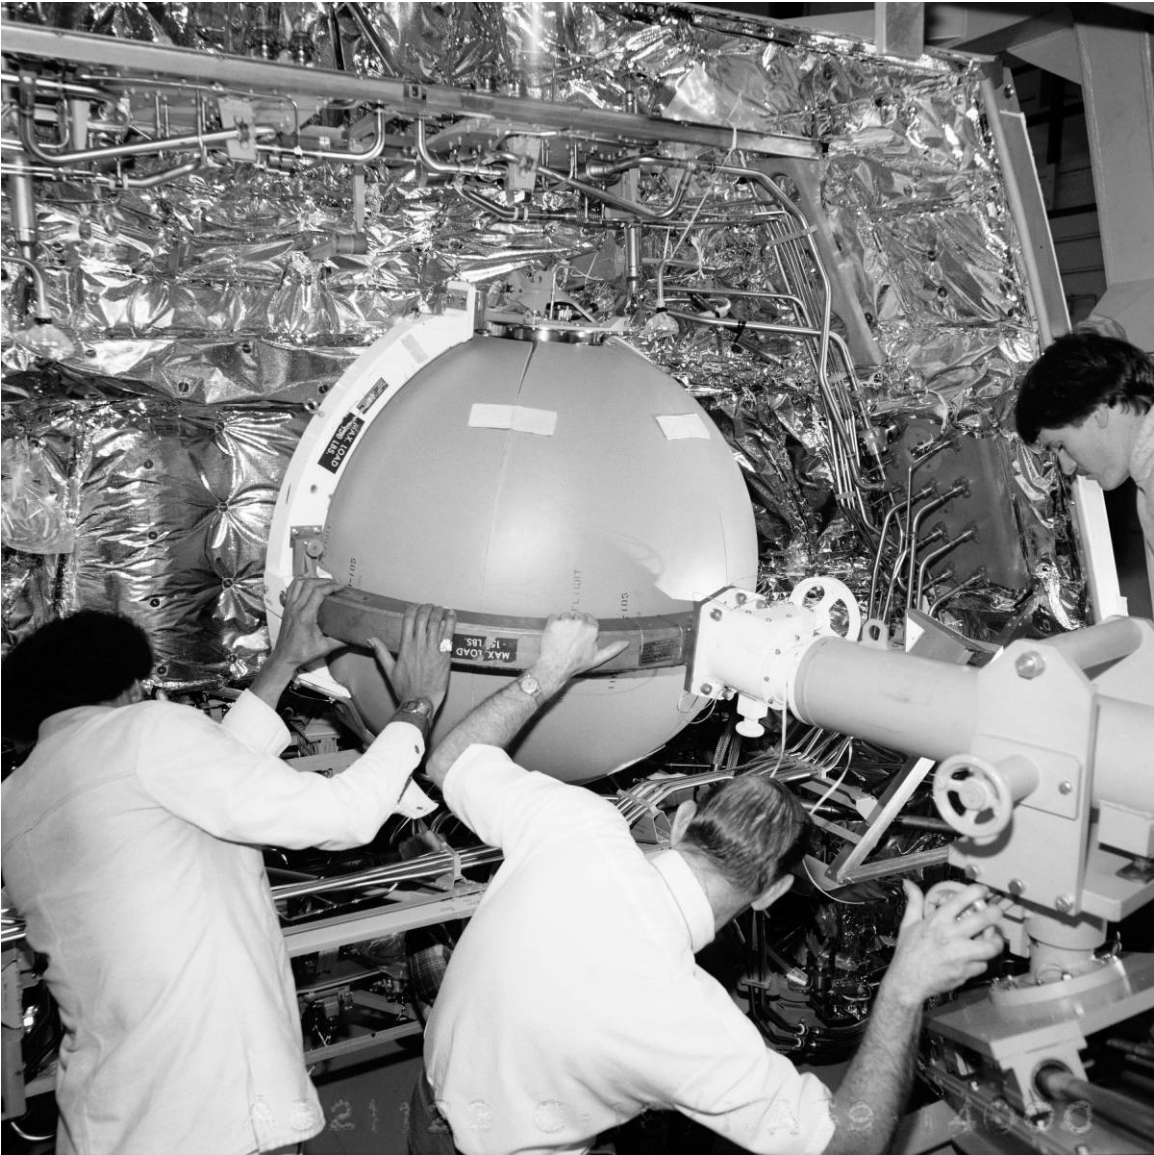
Figure B-14. Fuel tank being installed into *Discovery's* FRCS module, NAR Building 1, Downey, California, November 23, 1982.
Source: NASA, Johnson Space Center Image Repository, JSC2010-03369.

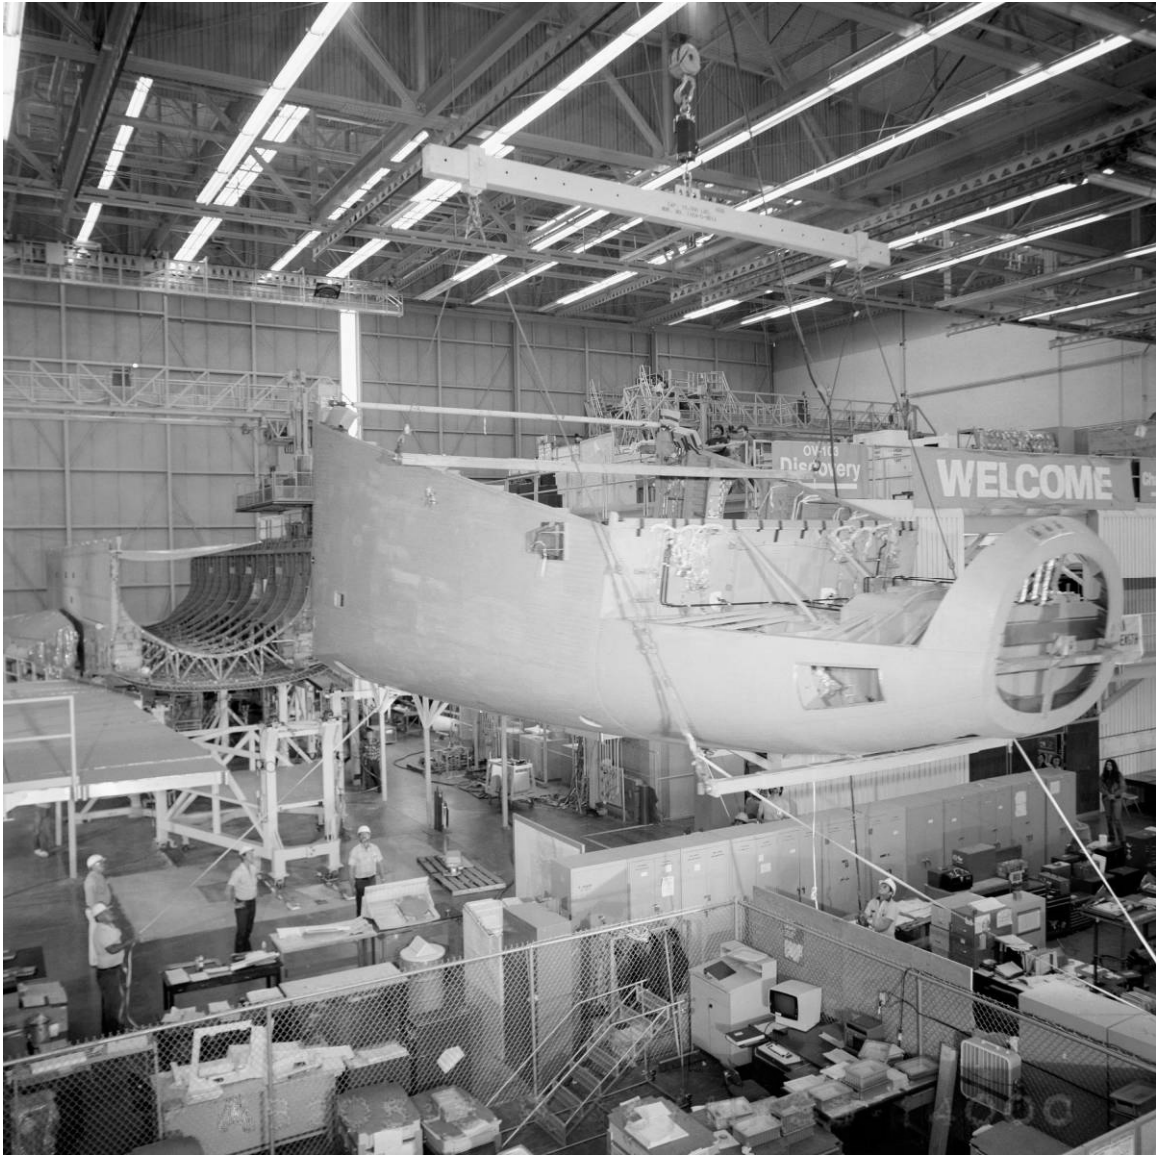
Figure B-24. *Discovery's* lower forward fuselage being attached to the midfuselage in High Bay 2, AFP 42, May 15, 1982.

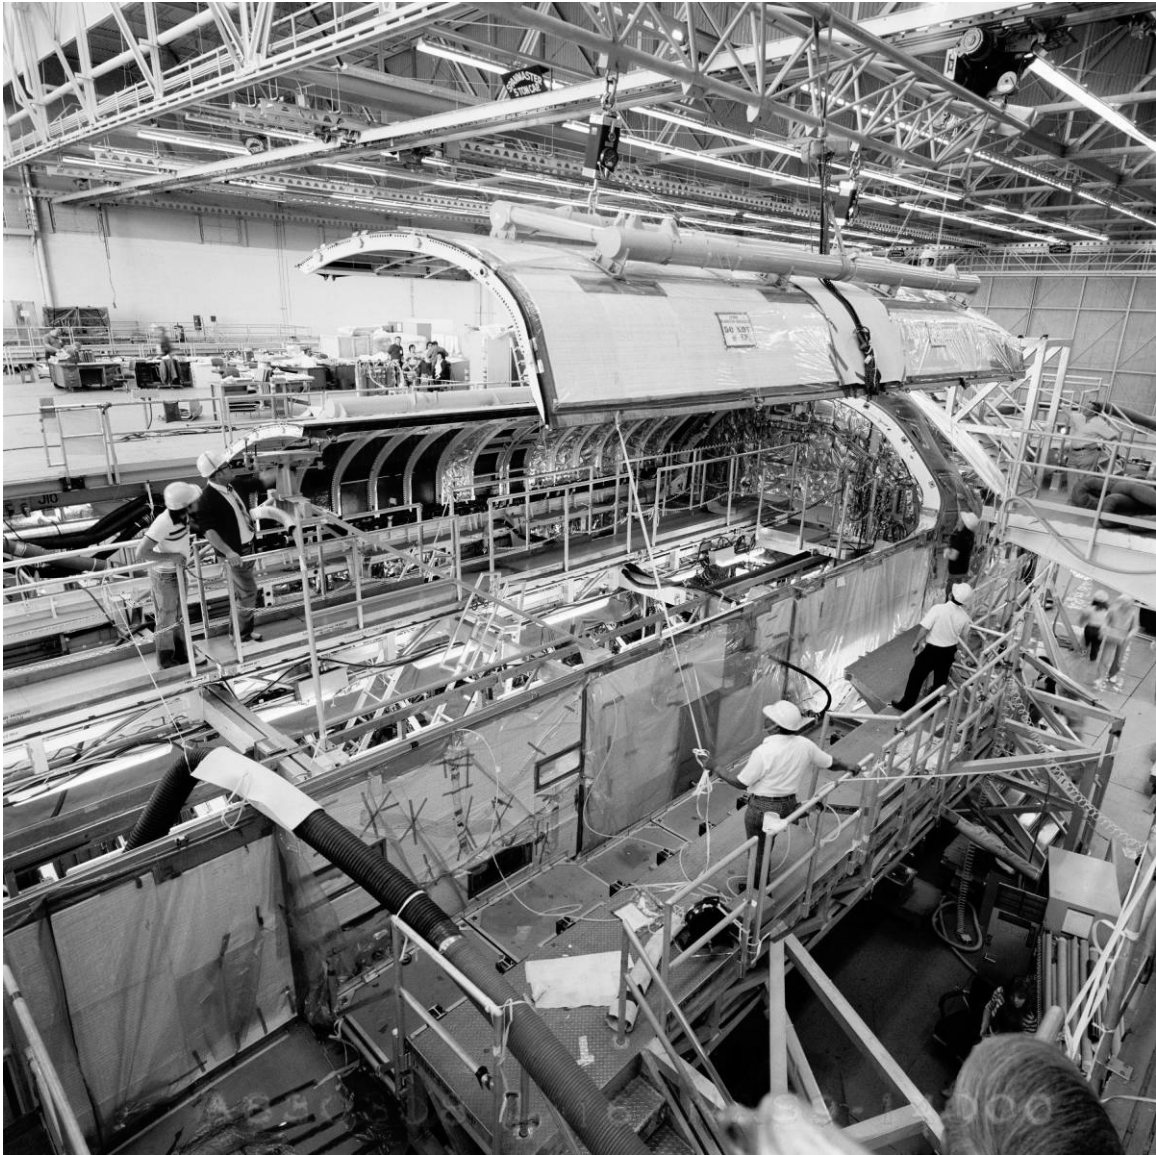
Figure B-44. Installation of the forward half of *Discovery's* starboard payload bay door in High Bay 2, AFP 42, March 8, 1983.
Source: NASA, Johnson Space Center Image Repository, JSC2010-03426.

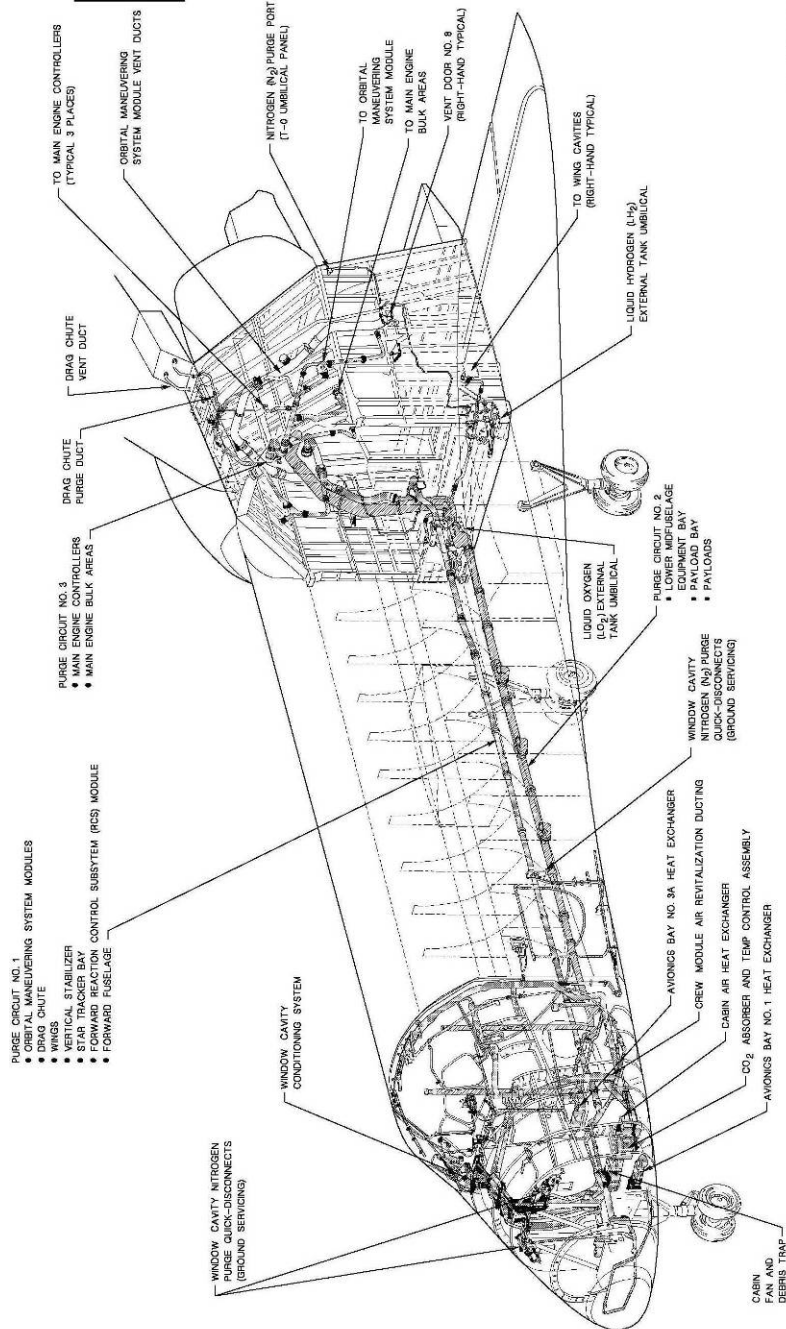
Figure B-118. Diagram of the ECLSS, purge, conditioning, air revitalization ducting.
 Source: NASA, *Shuttle Operational Data Book*, Volume 4, part 1, Figure 2-10a.

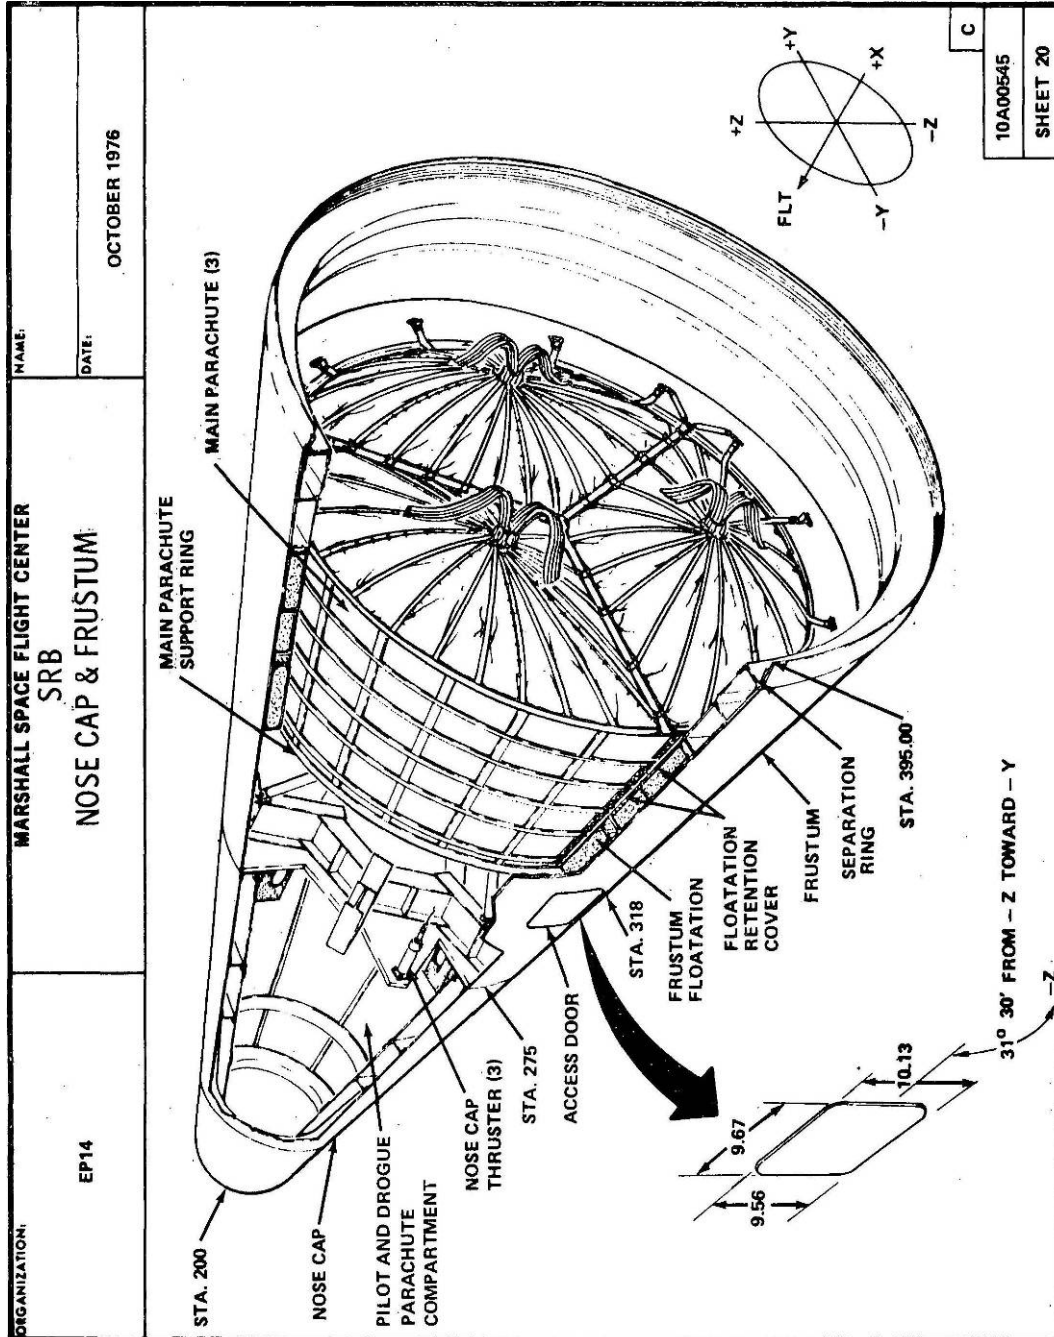
Figure No. E-14. Diagram of SRB nose cap and frustum.

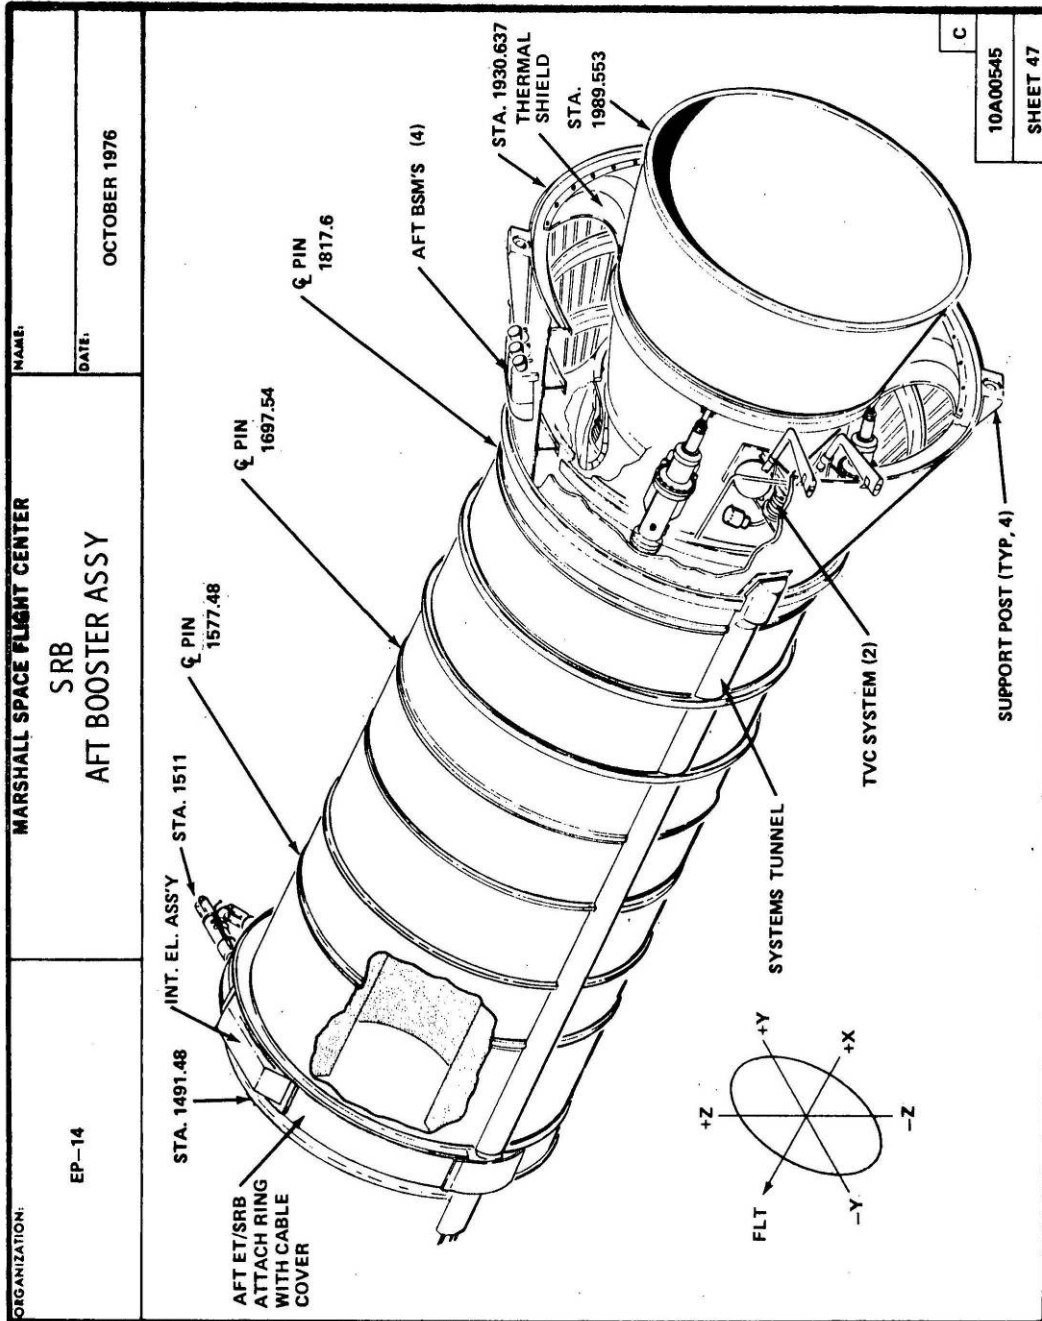
Figure No. E-24. Diagram of SRB aft booster assembly with skirt.
 Source: Griner, et al., *Space Shuttle Solid Rocket Booster Pictorial Representations*, sheet 47.

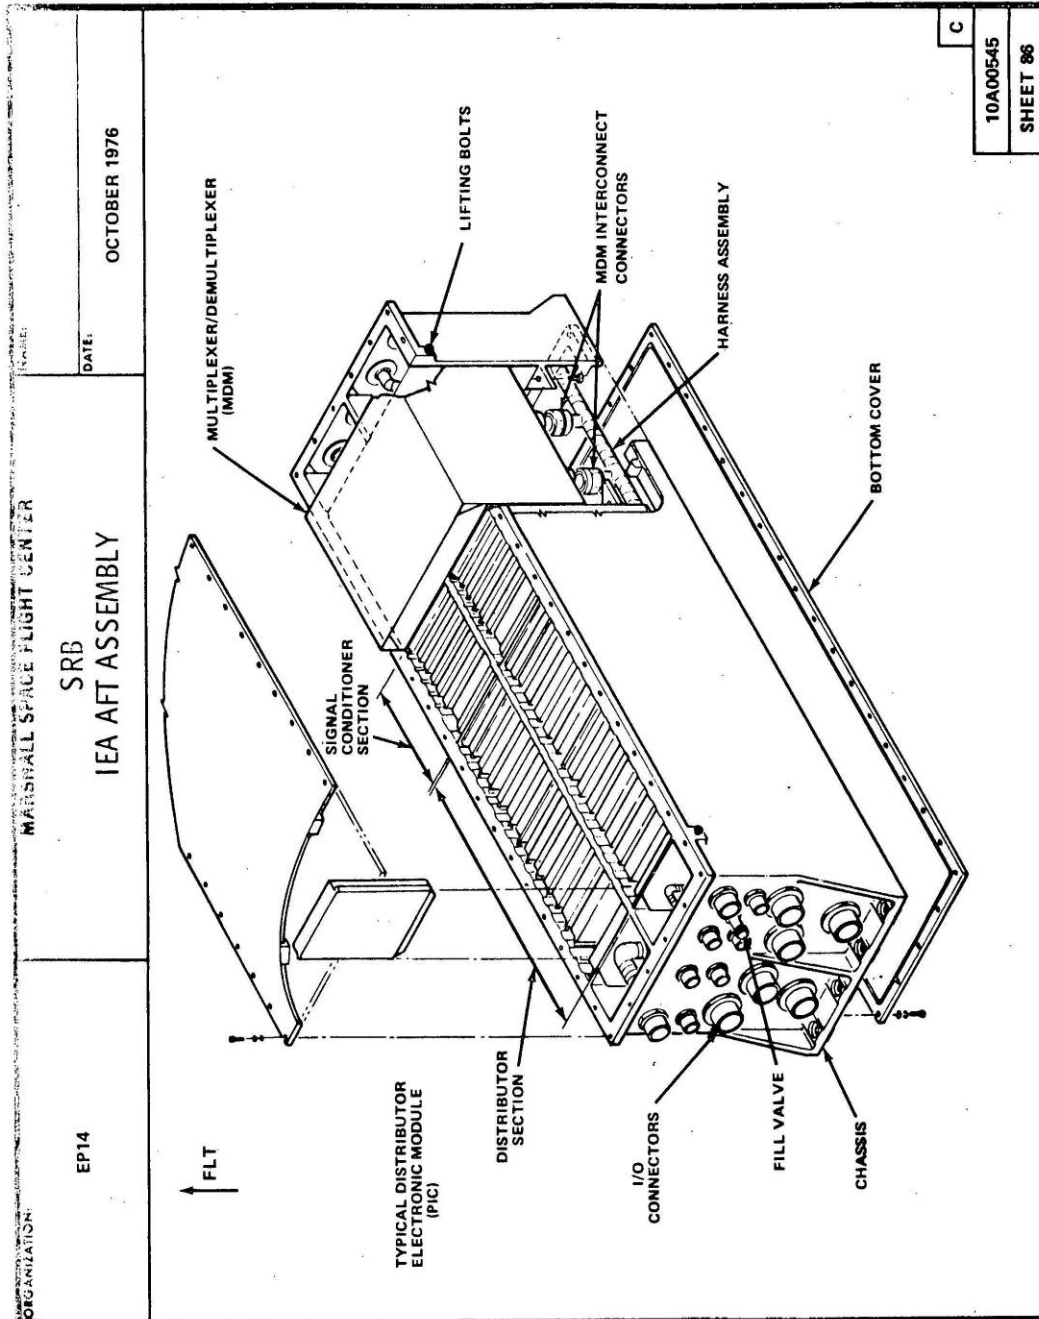
Figure No. E-27. SRB Integrated Electronic Assembly (IEA).
Source: Griner, et al., *Space Shuttle Solid Rocket Booster Pictorial Representations*, sheet 86.
